Document: #HT000060

Document Title: Adjust Ribbon Out Sensor

Product(s): Ti-1000

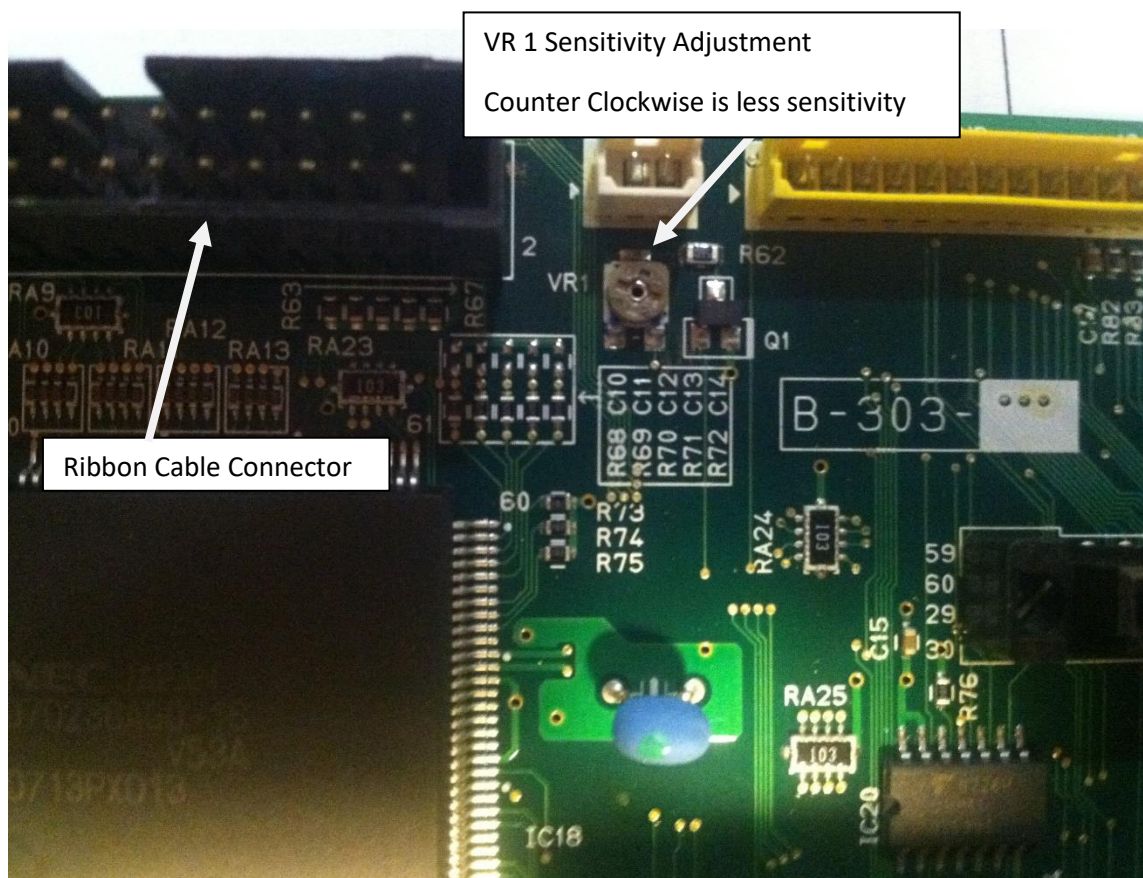
VR 1 Sensitivity Adjustment
Counter Clockwise is less sensitivity

Ribbon Cable Connector

CPU Board

Important: Make sure you remember the starting position of the VR1 control before adjusting. If the adjustment does not work, return VR1 to the original position.

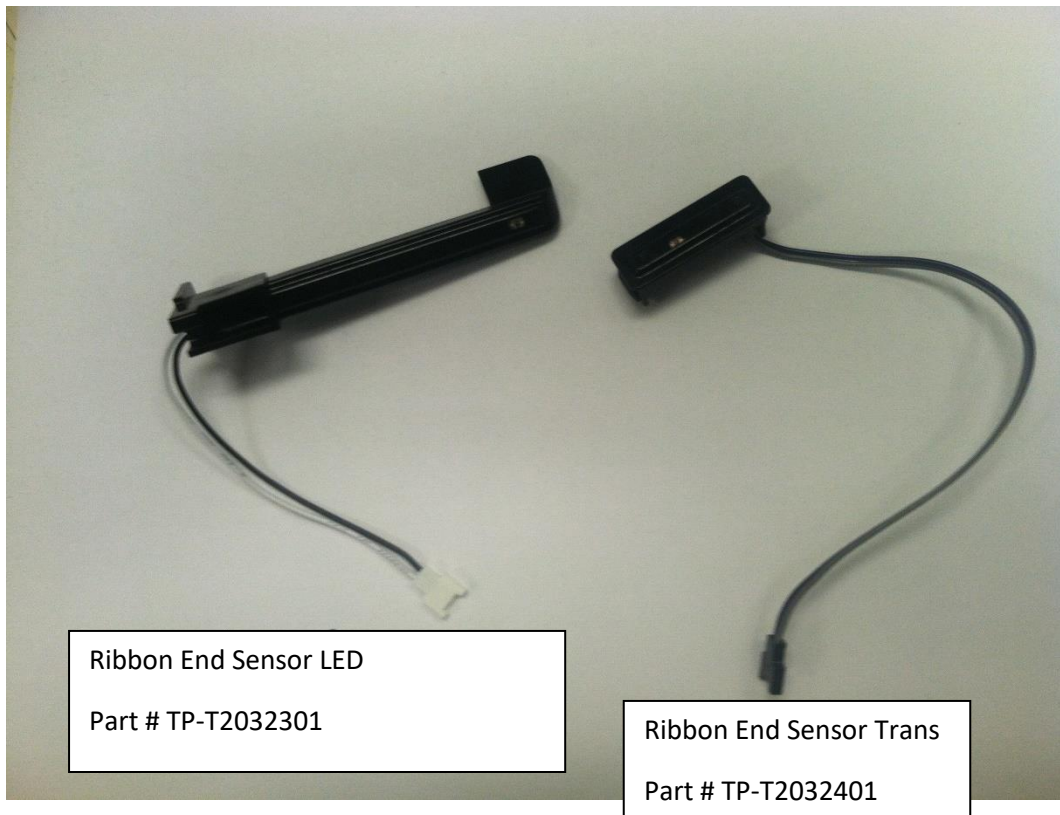
Your Ribbon Out Sensors may not be working, in which case it will be necessary to replace the sensors. Since it is very difficult to determine which sensor is malfunctioning, APP recommends replacing both sensors.
