Document: #HT000070

Document Title: Fix Ribbon Wrinkles

Product(s): Ti-1000

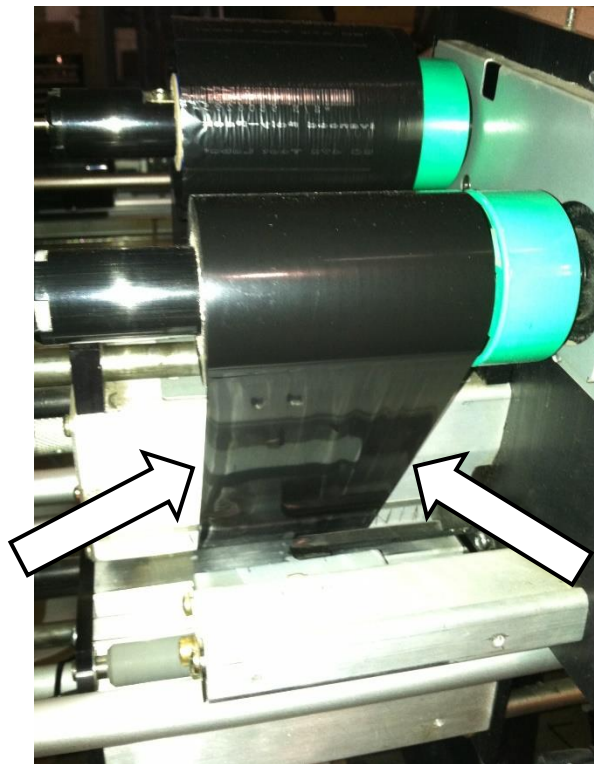
Advance the Take up roller to put tension on the Ribbon. Lightly touch each side of the Ribbon from the Unwind Spindle. You should have even tension. If not, you may have a bent Ribbon Spindle.

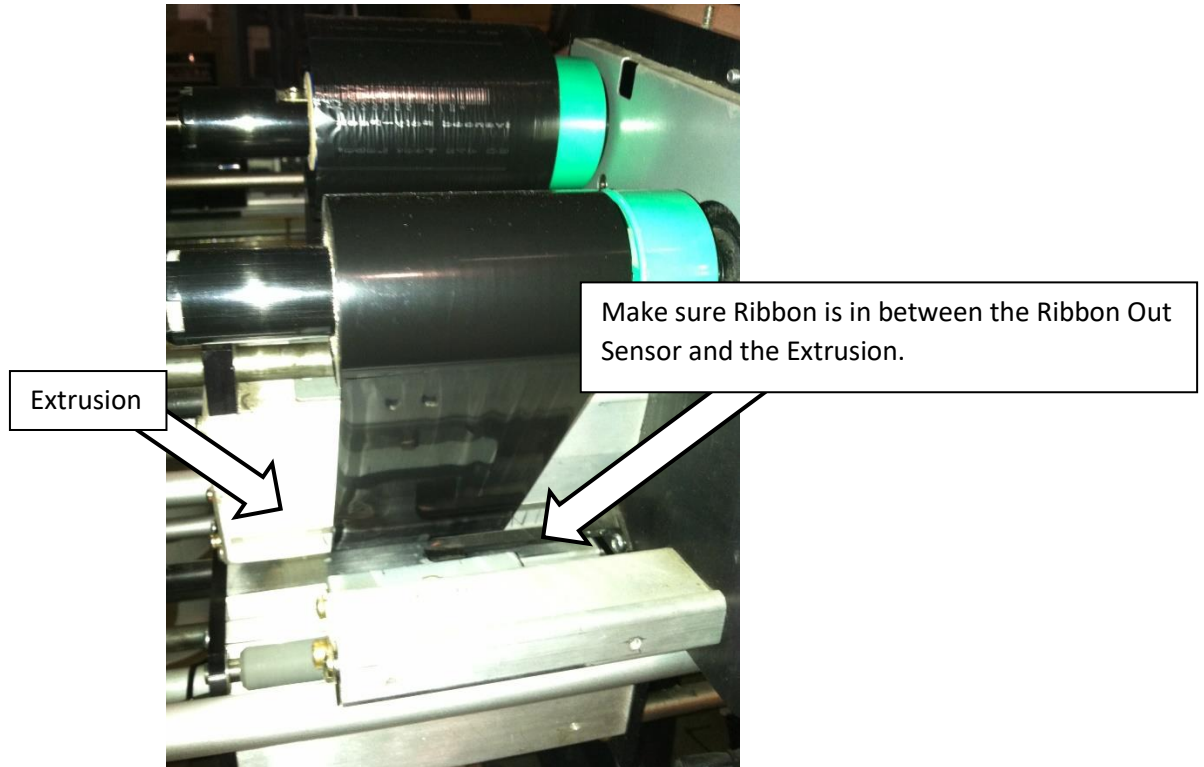
Make sure Ribbon is in between the black Ribbon Out Sensor and the Extrusion.

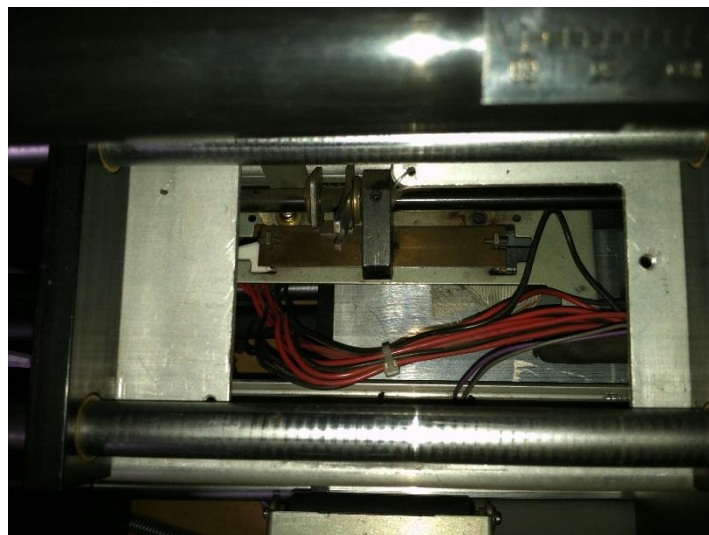
Look in the top of Printer and make sure wires that go to Print Head are not hanging down touching ribbon.
