Document: #HT000185

Document Title: Error Messages / PLC Issues

Product(s): T-1000 Baggers, Ti-1000Z Printers, US-5500 Scale

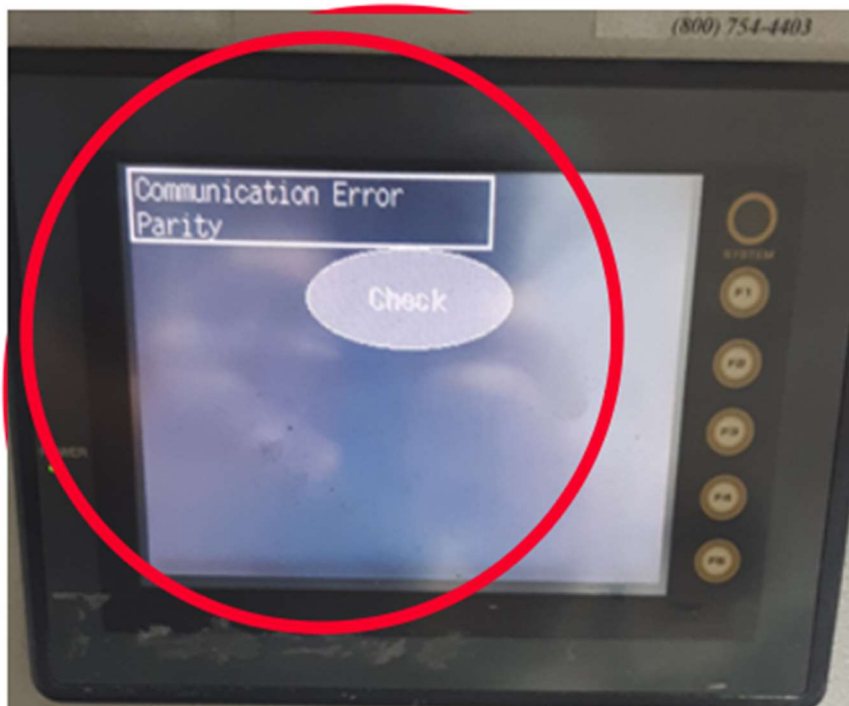
Touch Screen Communication Error

Some Models of Touch Screen displays DATA LOADING

A communication error displayed on the Touch Screen normally is a result of a lost connection with the PLC in the bagger.

Follow the communication cable from the Touch Screen to the bagger PLC. Check the connections at both ends of the cable and look for a disconnect wire.

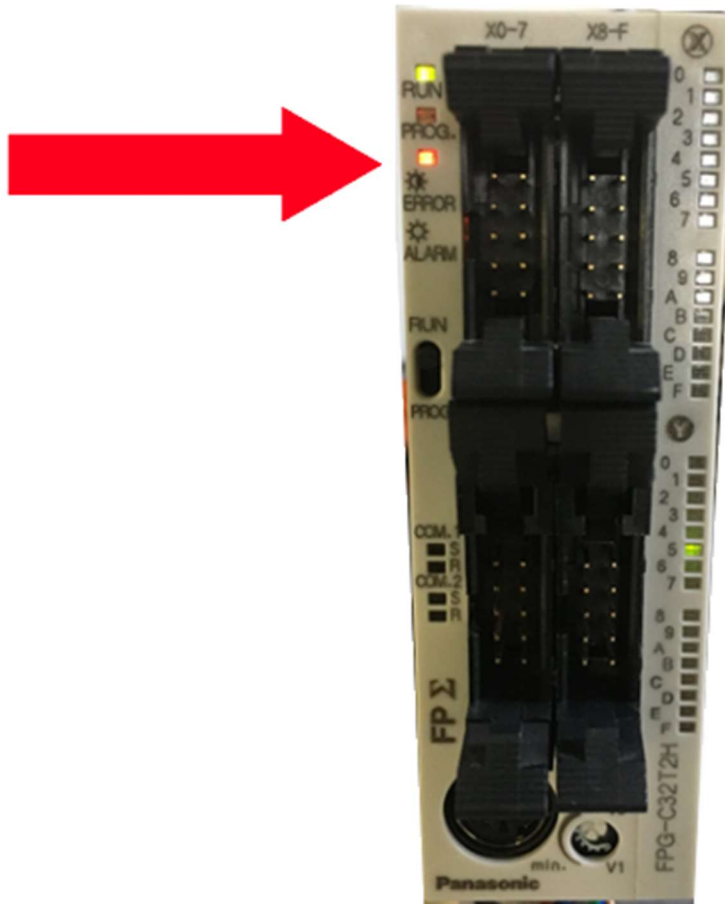
If no wire is disconnected at either end of the cable check the PLC for a RED Error light. The battery in the PLC may need replaced and the PLC re-programmed.

NOTE: The PLC could be Green as well as Light Grey

Click on the Link below to access PLC Re-program options.
