**Document: #HT000013**

**Document Title: Print Head Cylinder Adjustment**

**Product(s): T-375**

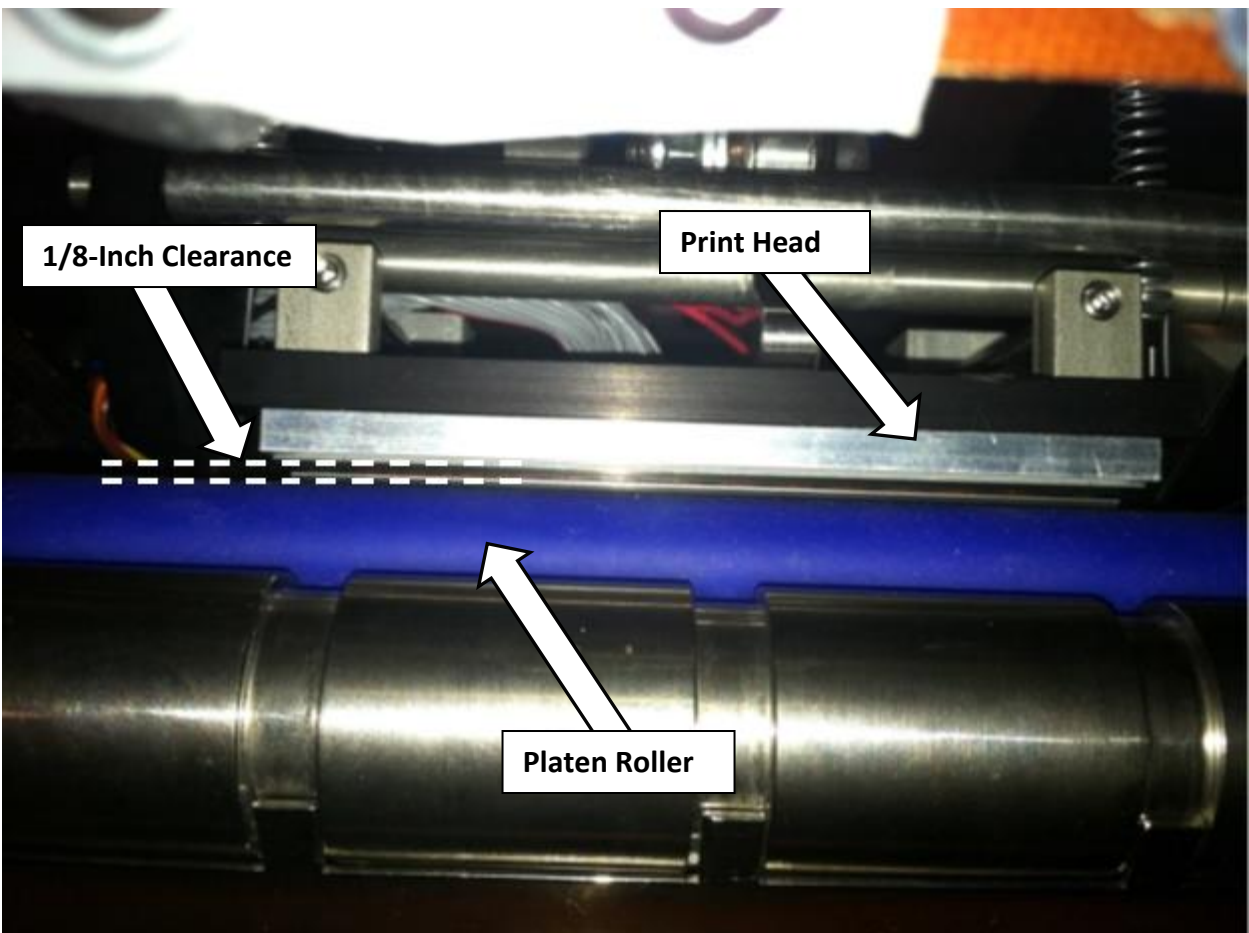
Check the clearance between the Print Head and Platen Roller, it should be 1/8-inch. If not, proceed with the following adjustments.

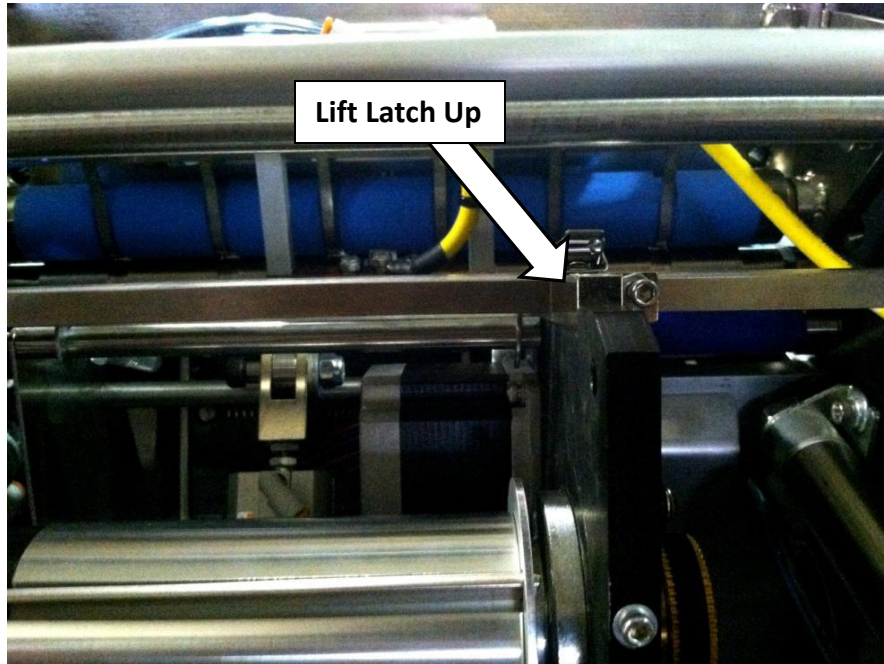
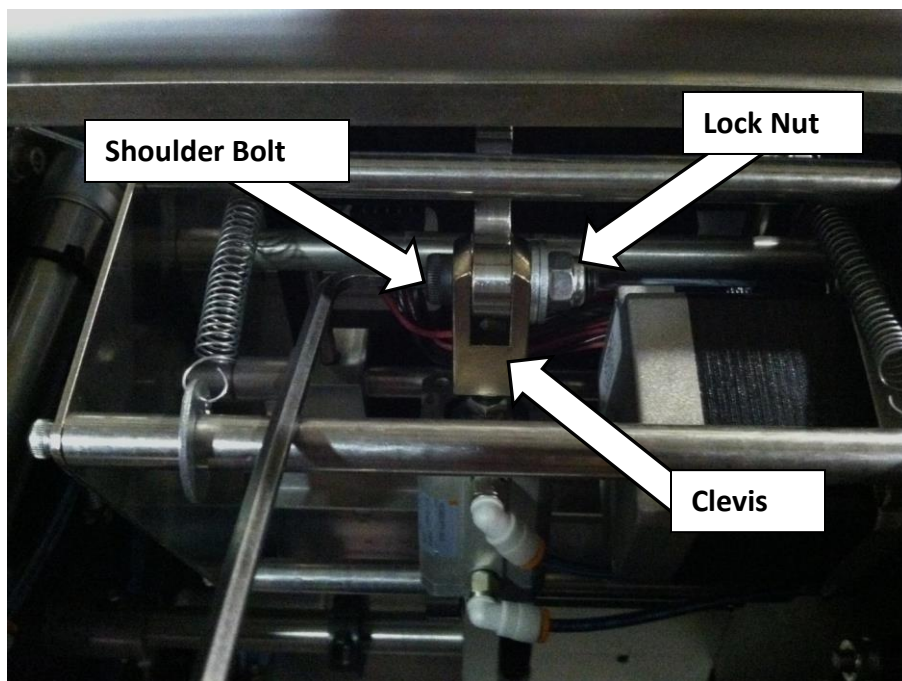
Lift Latch up to unlock. Gently tilt the Printer back.

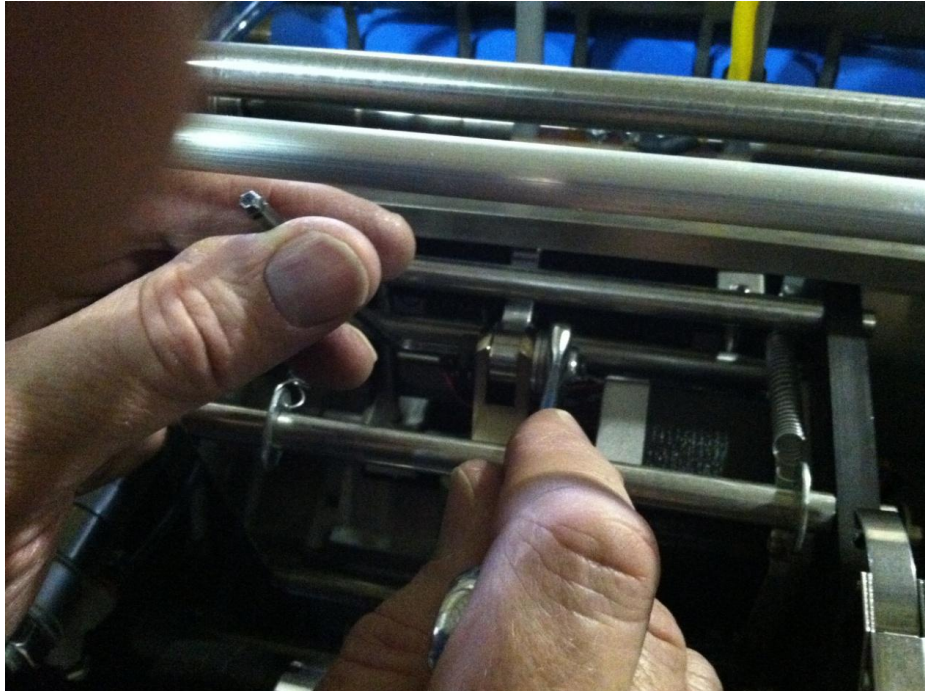
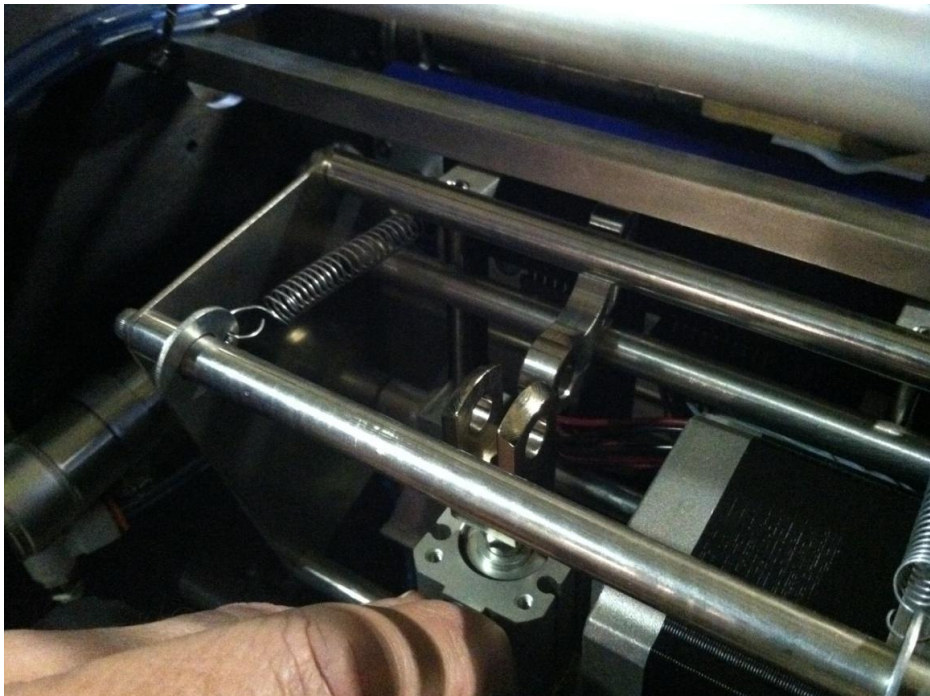
Loosen the Nut and remove Shoulder Bolt.

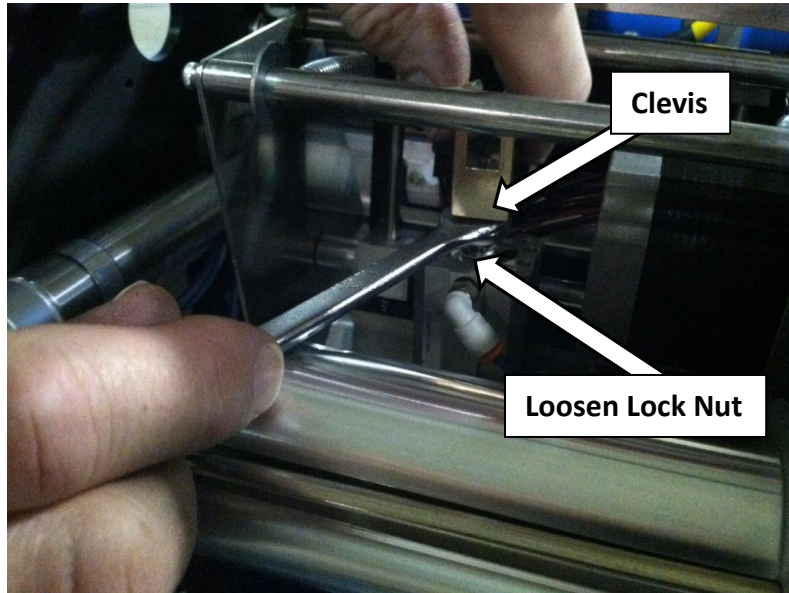
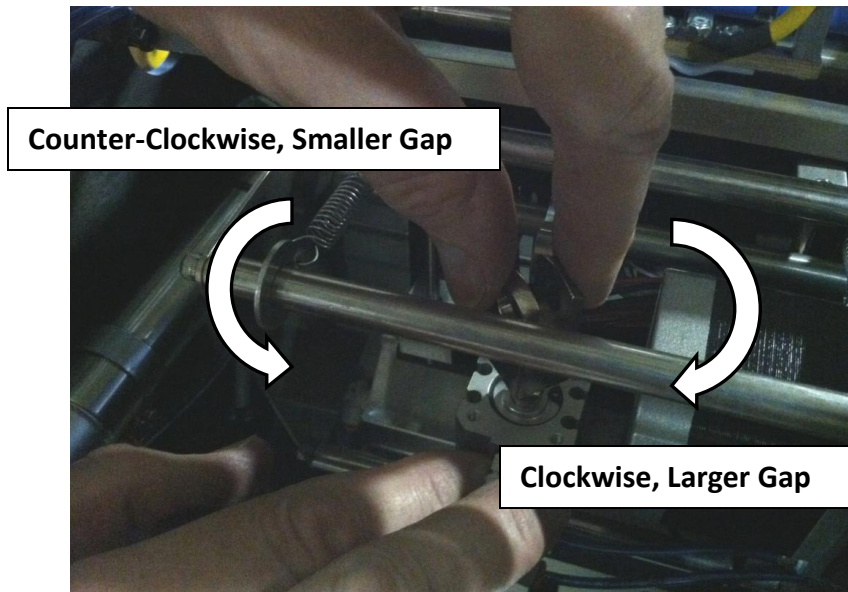
Loosen the Lock Nut just below the Clevis.

Turn the Clevis 1/2-turn clockwise to make the distance between the Platen Roller and Print Head wider, or turn the Clevis 1/2- turn counter-clockwise to make the gap between the Platen Roller and Print Head smaller. Do not tighten Lock Nut yet.

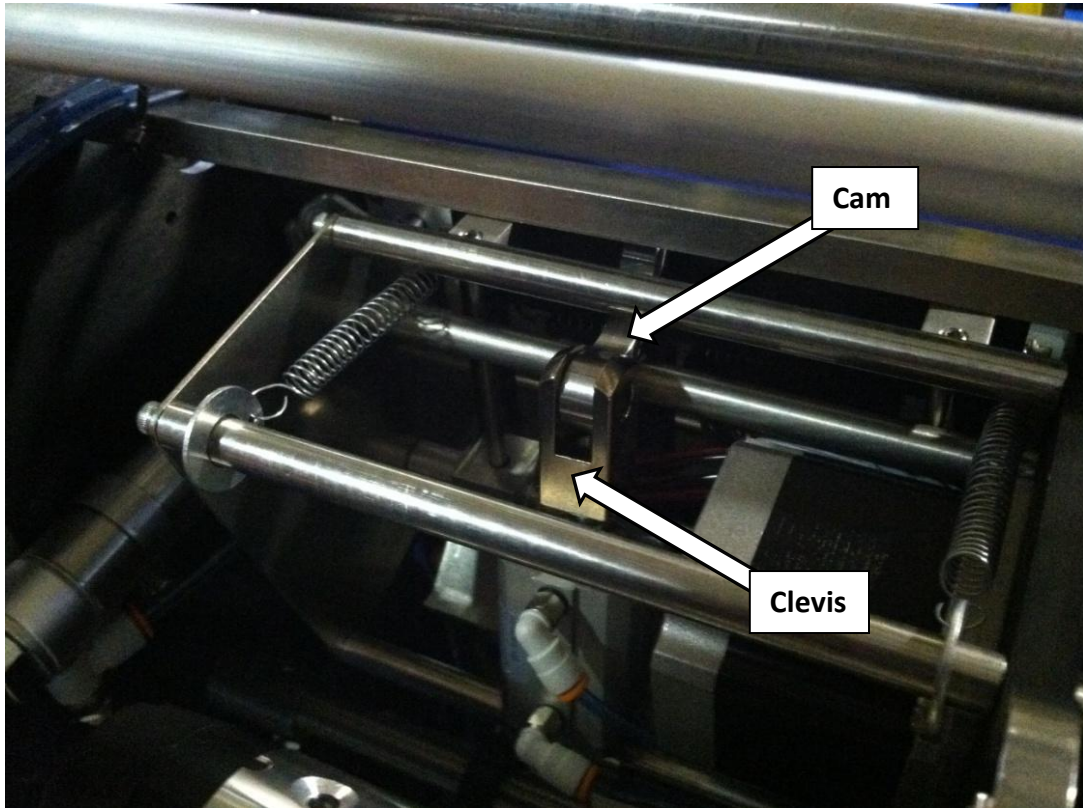
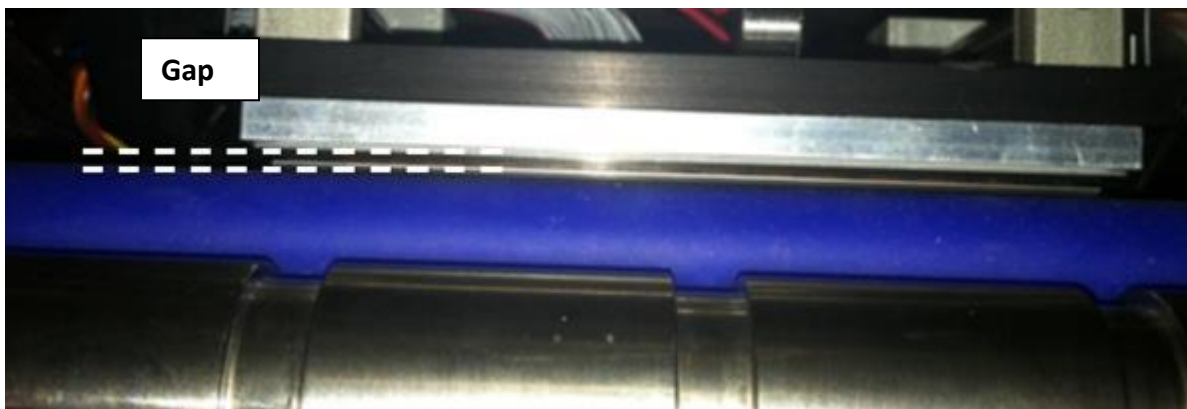
Put the Shoulder Bolt into the Clevis and Cam; do not put Lock Nut on yet.  
Turn Air On. Now check the gap between Platen Roller and Print Head.

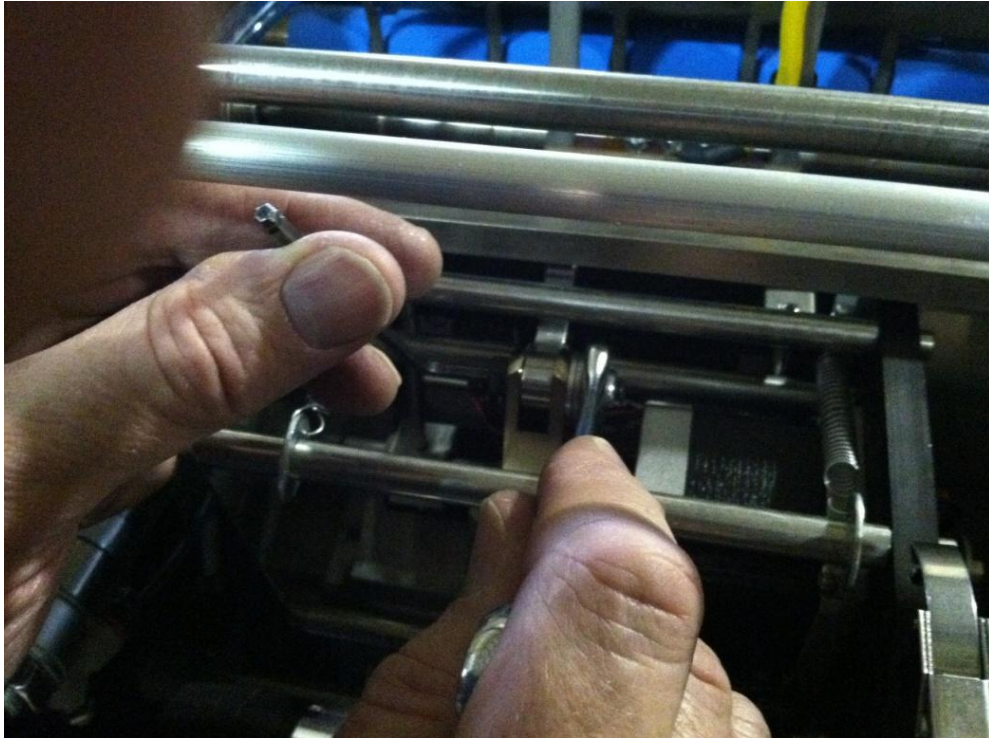
Once you have achieved the 1/8-inch Gap, replace the Lock Nut on Shoulder Bolt and Tighten.

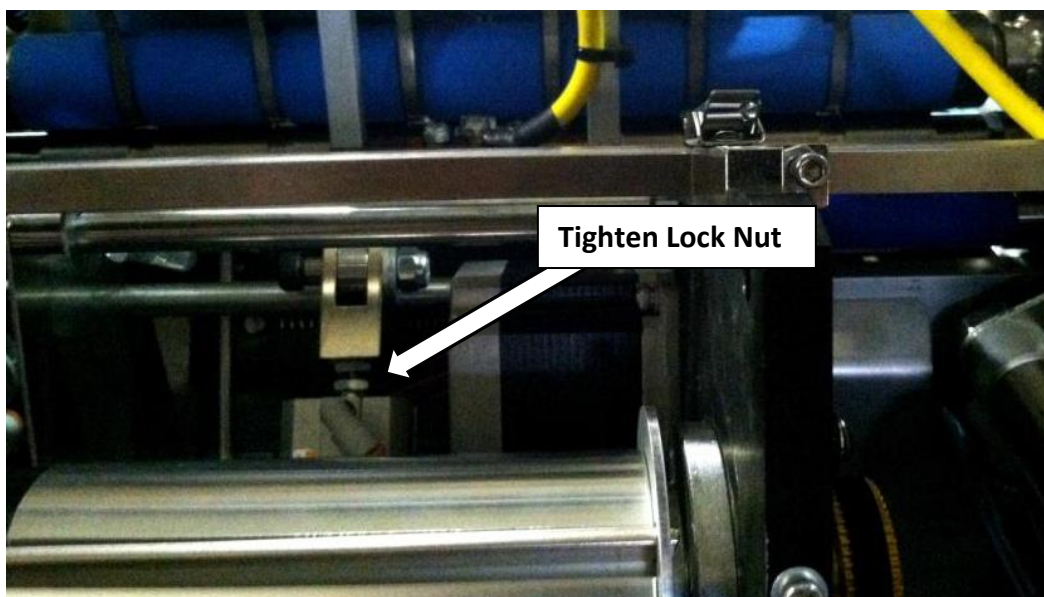
Now tighten Lock Nut on the bottom of the Clevis (see below).
