Document: #HT000022

Document Title: Blue Roller Adjustment

Product(s): T-300/375

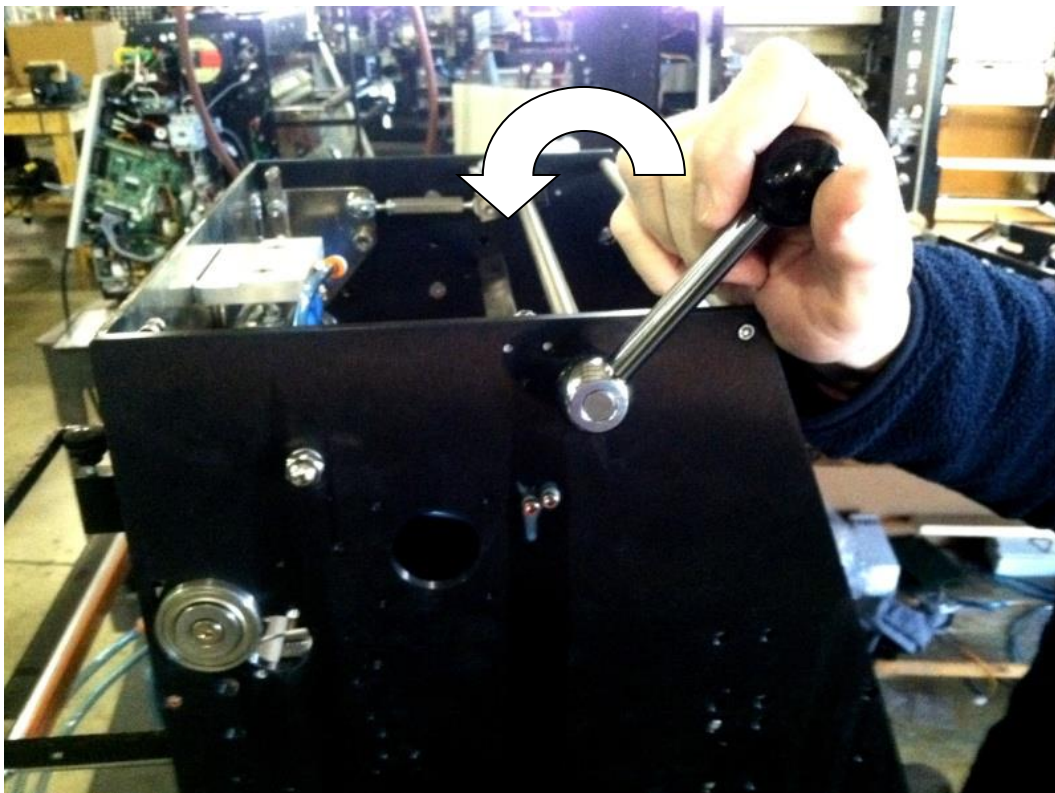
Move Handle to slightly separate the Blue Roller from the Steel Roller.

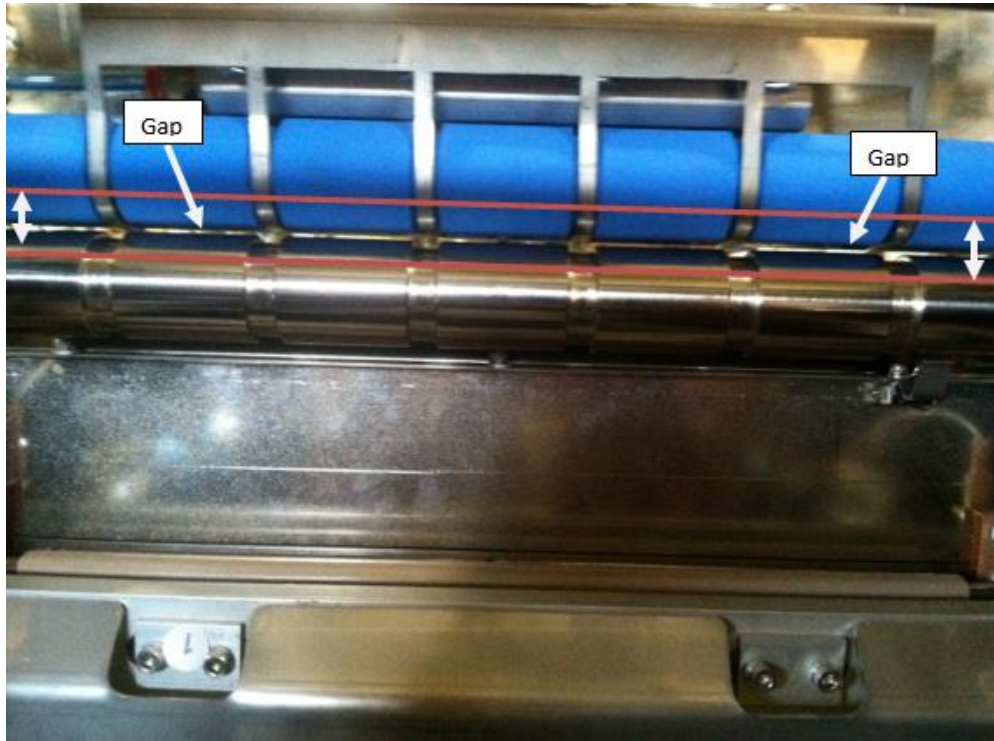
Visually check the Gap between the Blue Roller and Steel Roller, the Gap should be the same all the way across.

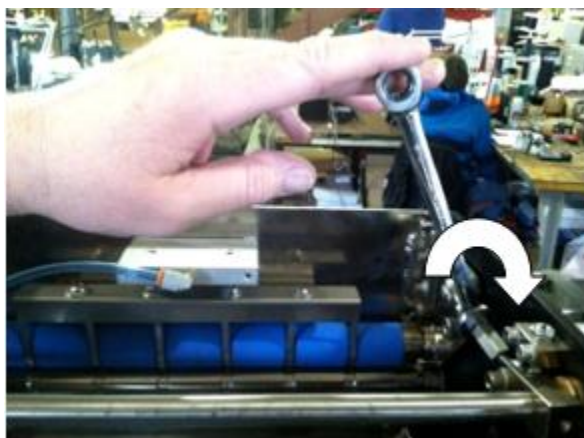
Loosen Lock Nuts on both sides of Bagger with two 7/16 wrenches

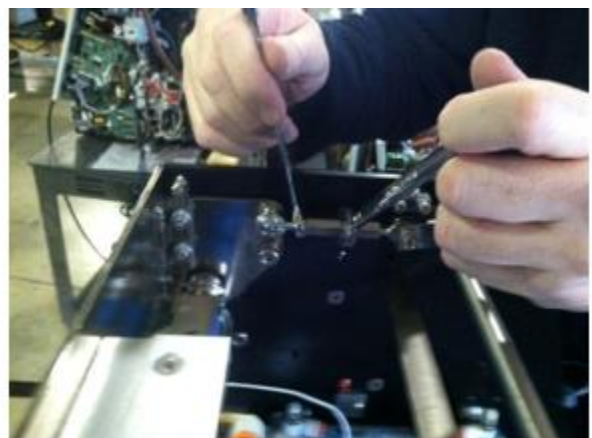
(View from back of Bagger)

Turn Lock Nut to the right to loosen. While holding Turnbuckle, loosen Lock Nut.

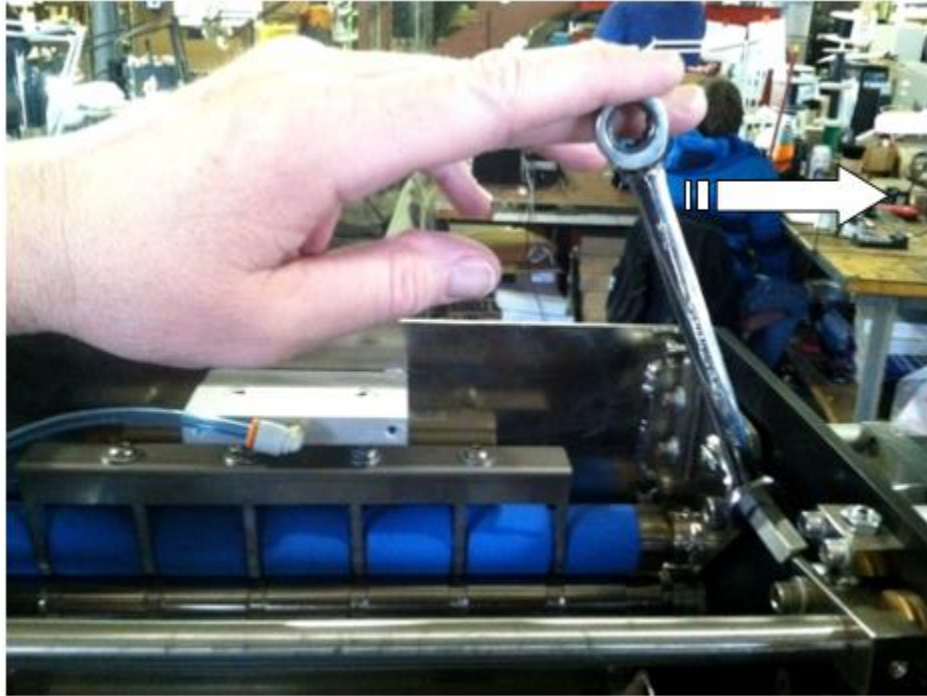
(View from back of Bagger)

Moving the Turnbuckle to the right will make the Gap wider.

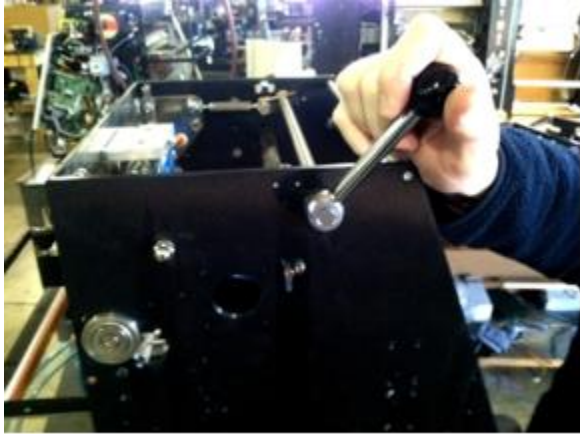
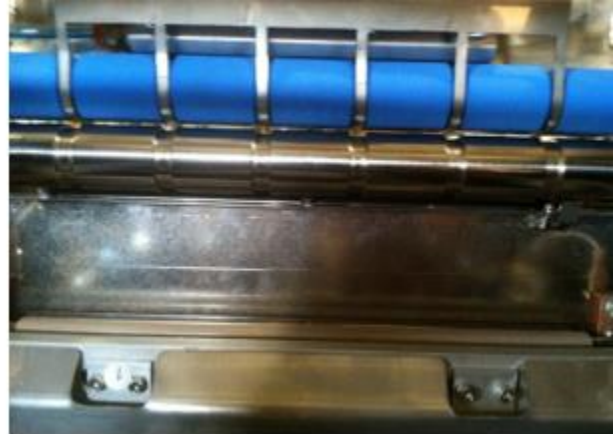
While making this adjustment, check for an even Gap between the Blue Roller and Steel Roller.

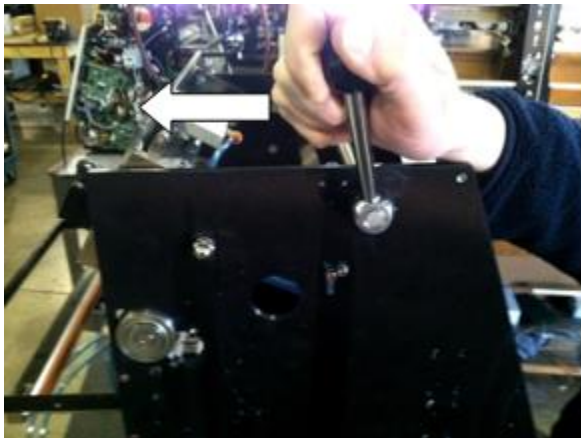
Open and Close the Rollers. You should feel it snap shut. It should not be real tight. If it is to tight, loosen both Turnbuckles and adjust for less Gap.

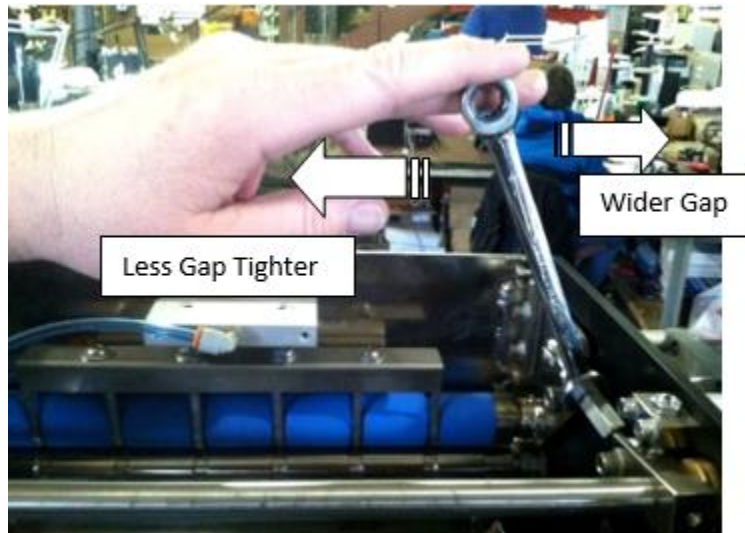
When completed, tighten Lock Nuts and check again.
