Document: #HT000070

Document Title: Fix Ribbon Wrinkles

Product(s): Ti-1000

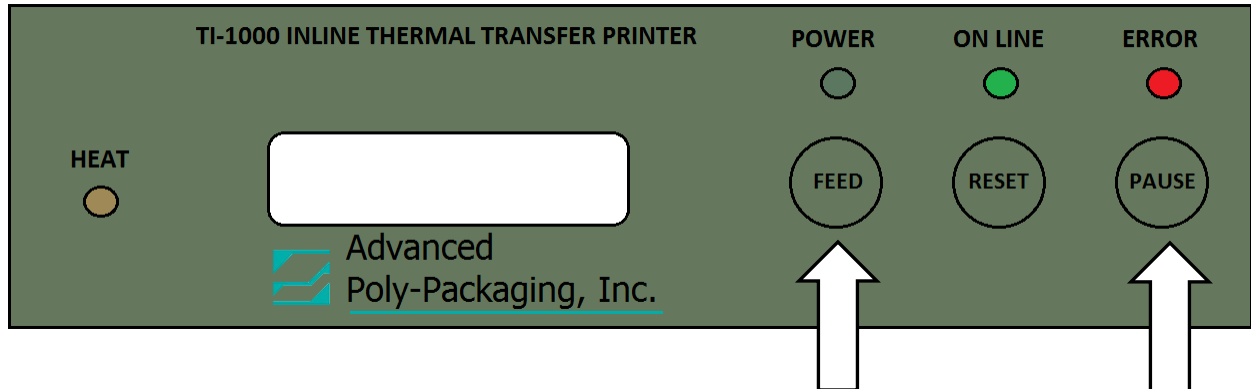
With power “OFF”, hold down “FEED” and “PAUSE” buttons on the control panel.

Perform “Ribbon Take-Up” Procedure below:

Turn power “ON” while holding the buttons. “DIAG V____” will be displayed on panel.
