**Document: #HT000006**

**Document Title: How to Diagnose PC Link Error**

**Product(s): T-1000**

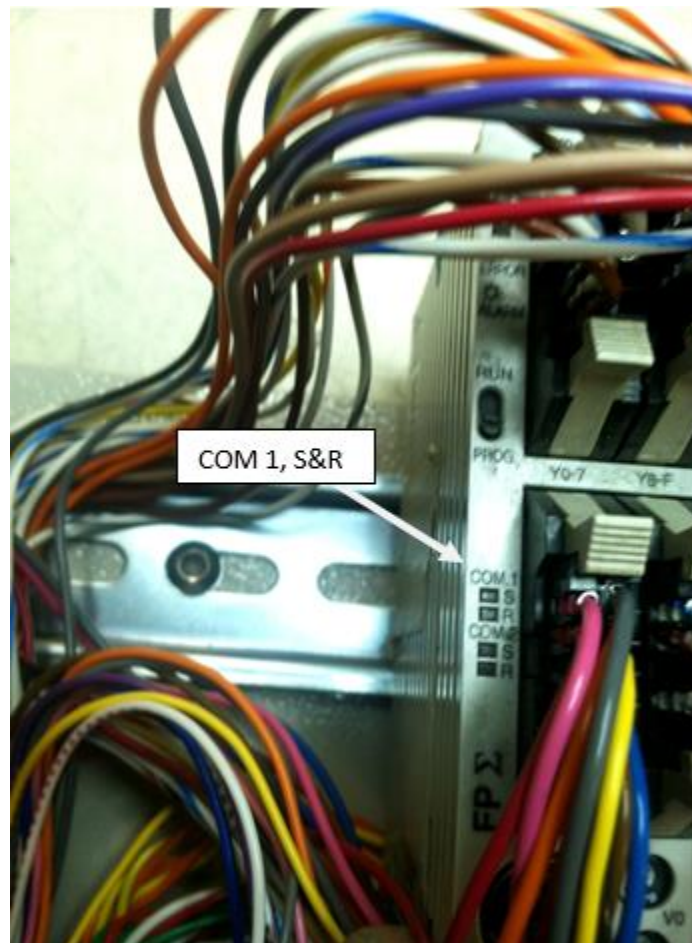
If the PLC is communicating with the PLC on the Printer, S and R on COM 1 should be flashing. This should be on both PLCs Bagger and Printer.

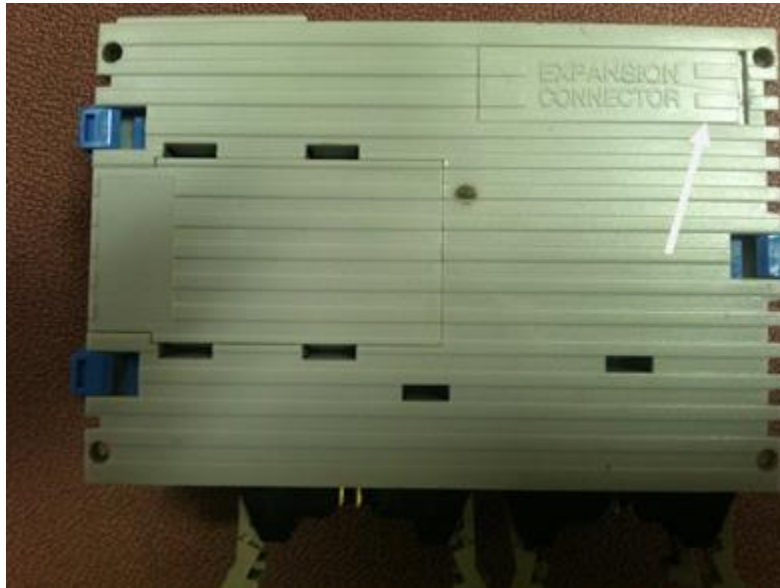
With a small screw driver open the Expansion Connector.
