Document: #HT000115

Document Title: Adjusting the Printer Pivot Block

Product(s): T-375 Printer

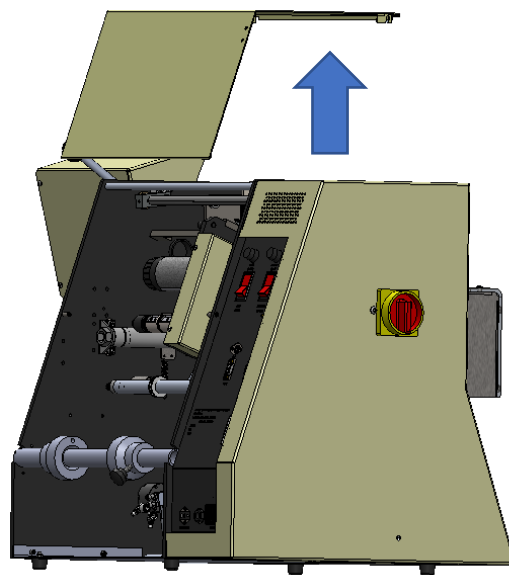
Turn Main Power 'OFF' and remove the Top Panel.

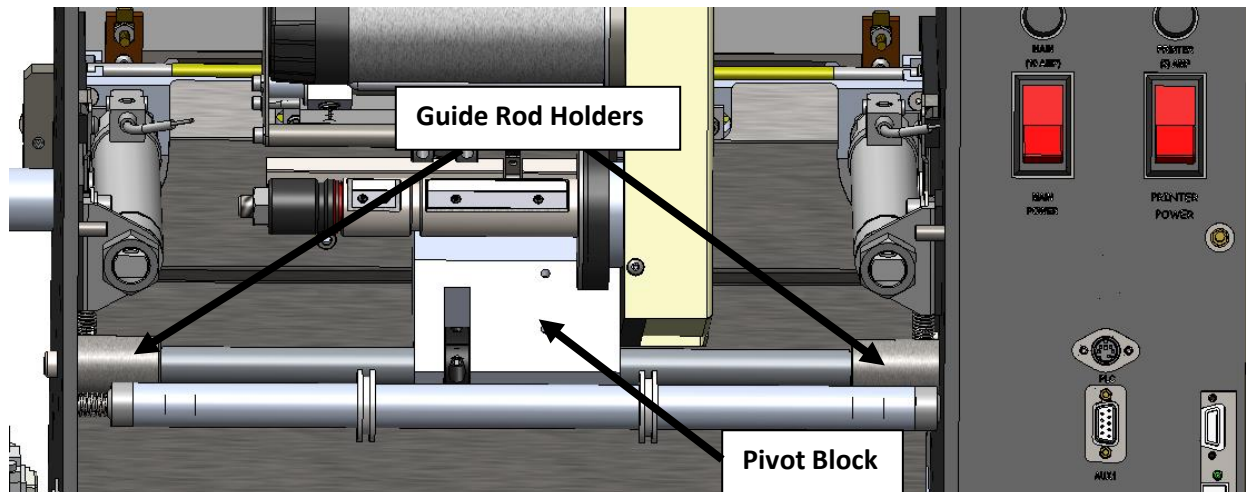
Locate the Guide Rod and Guide Rod Holders. These control the position of the Pivot Block.

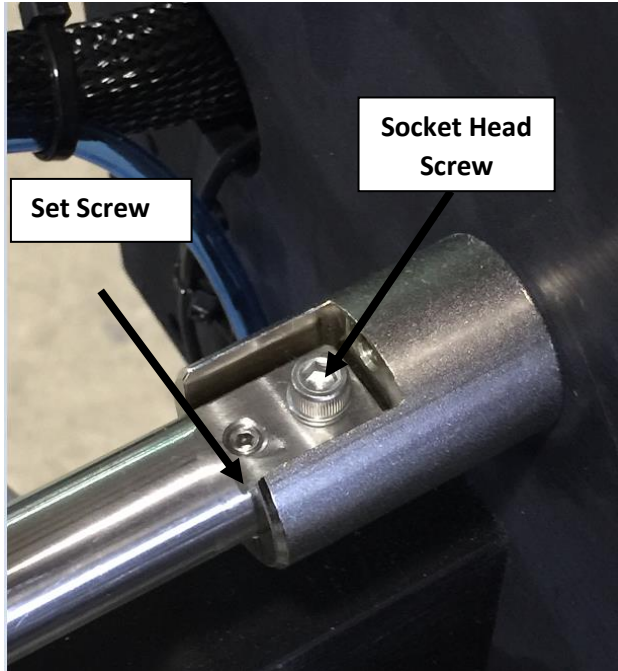
Examine the label printing for clarity, and determine which side is *not* printing clearly. Go to the Guide Rod Holder on the opposite side.

Loosen the Socket Head Screws on both Guide Rod Holders.

Tighten the adjacent Set Screw one full turn, then and re-tighten the Socket Head Screw on that side only.

Test the printing to determine if the quality has improved. If necessary, repeat the process, tightening the Set Screw one full turn each time, until the quality is satisfactory. When finished, tighten the Socket Head Screws on both sides.
